Conceptual Design Report
Bank Removal and Restoration – Plainwell No. 2 Dam Area
Allied Paper, Inc./Portage Creek/Kalamazoo River Superfund Site

November 2008

KALAMAZOO RIVER STUDY GROUP
ALLIED PAPER, INC./PORTAGE CREEK/
KALAMAZOO RIVER SUPERFUND SITE
CONCEPTUAL DESIGN REPORT FOR BANK REMOVAL
AND RESTORATION PLAINWELL NO. 2 DAM AREA

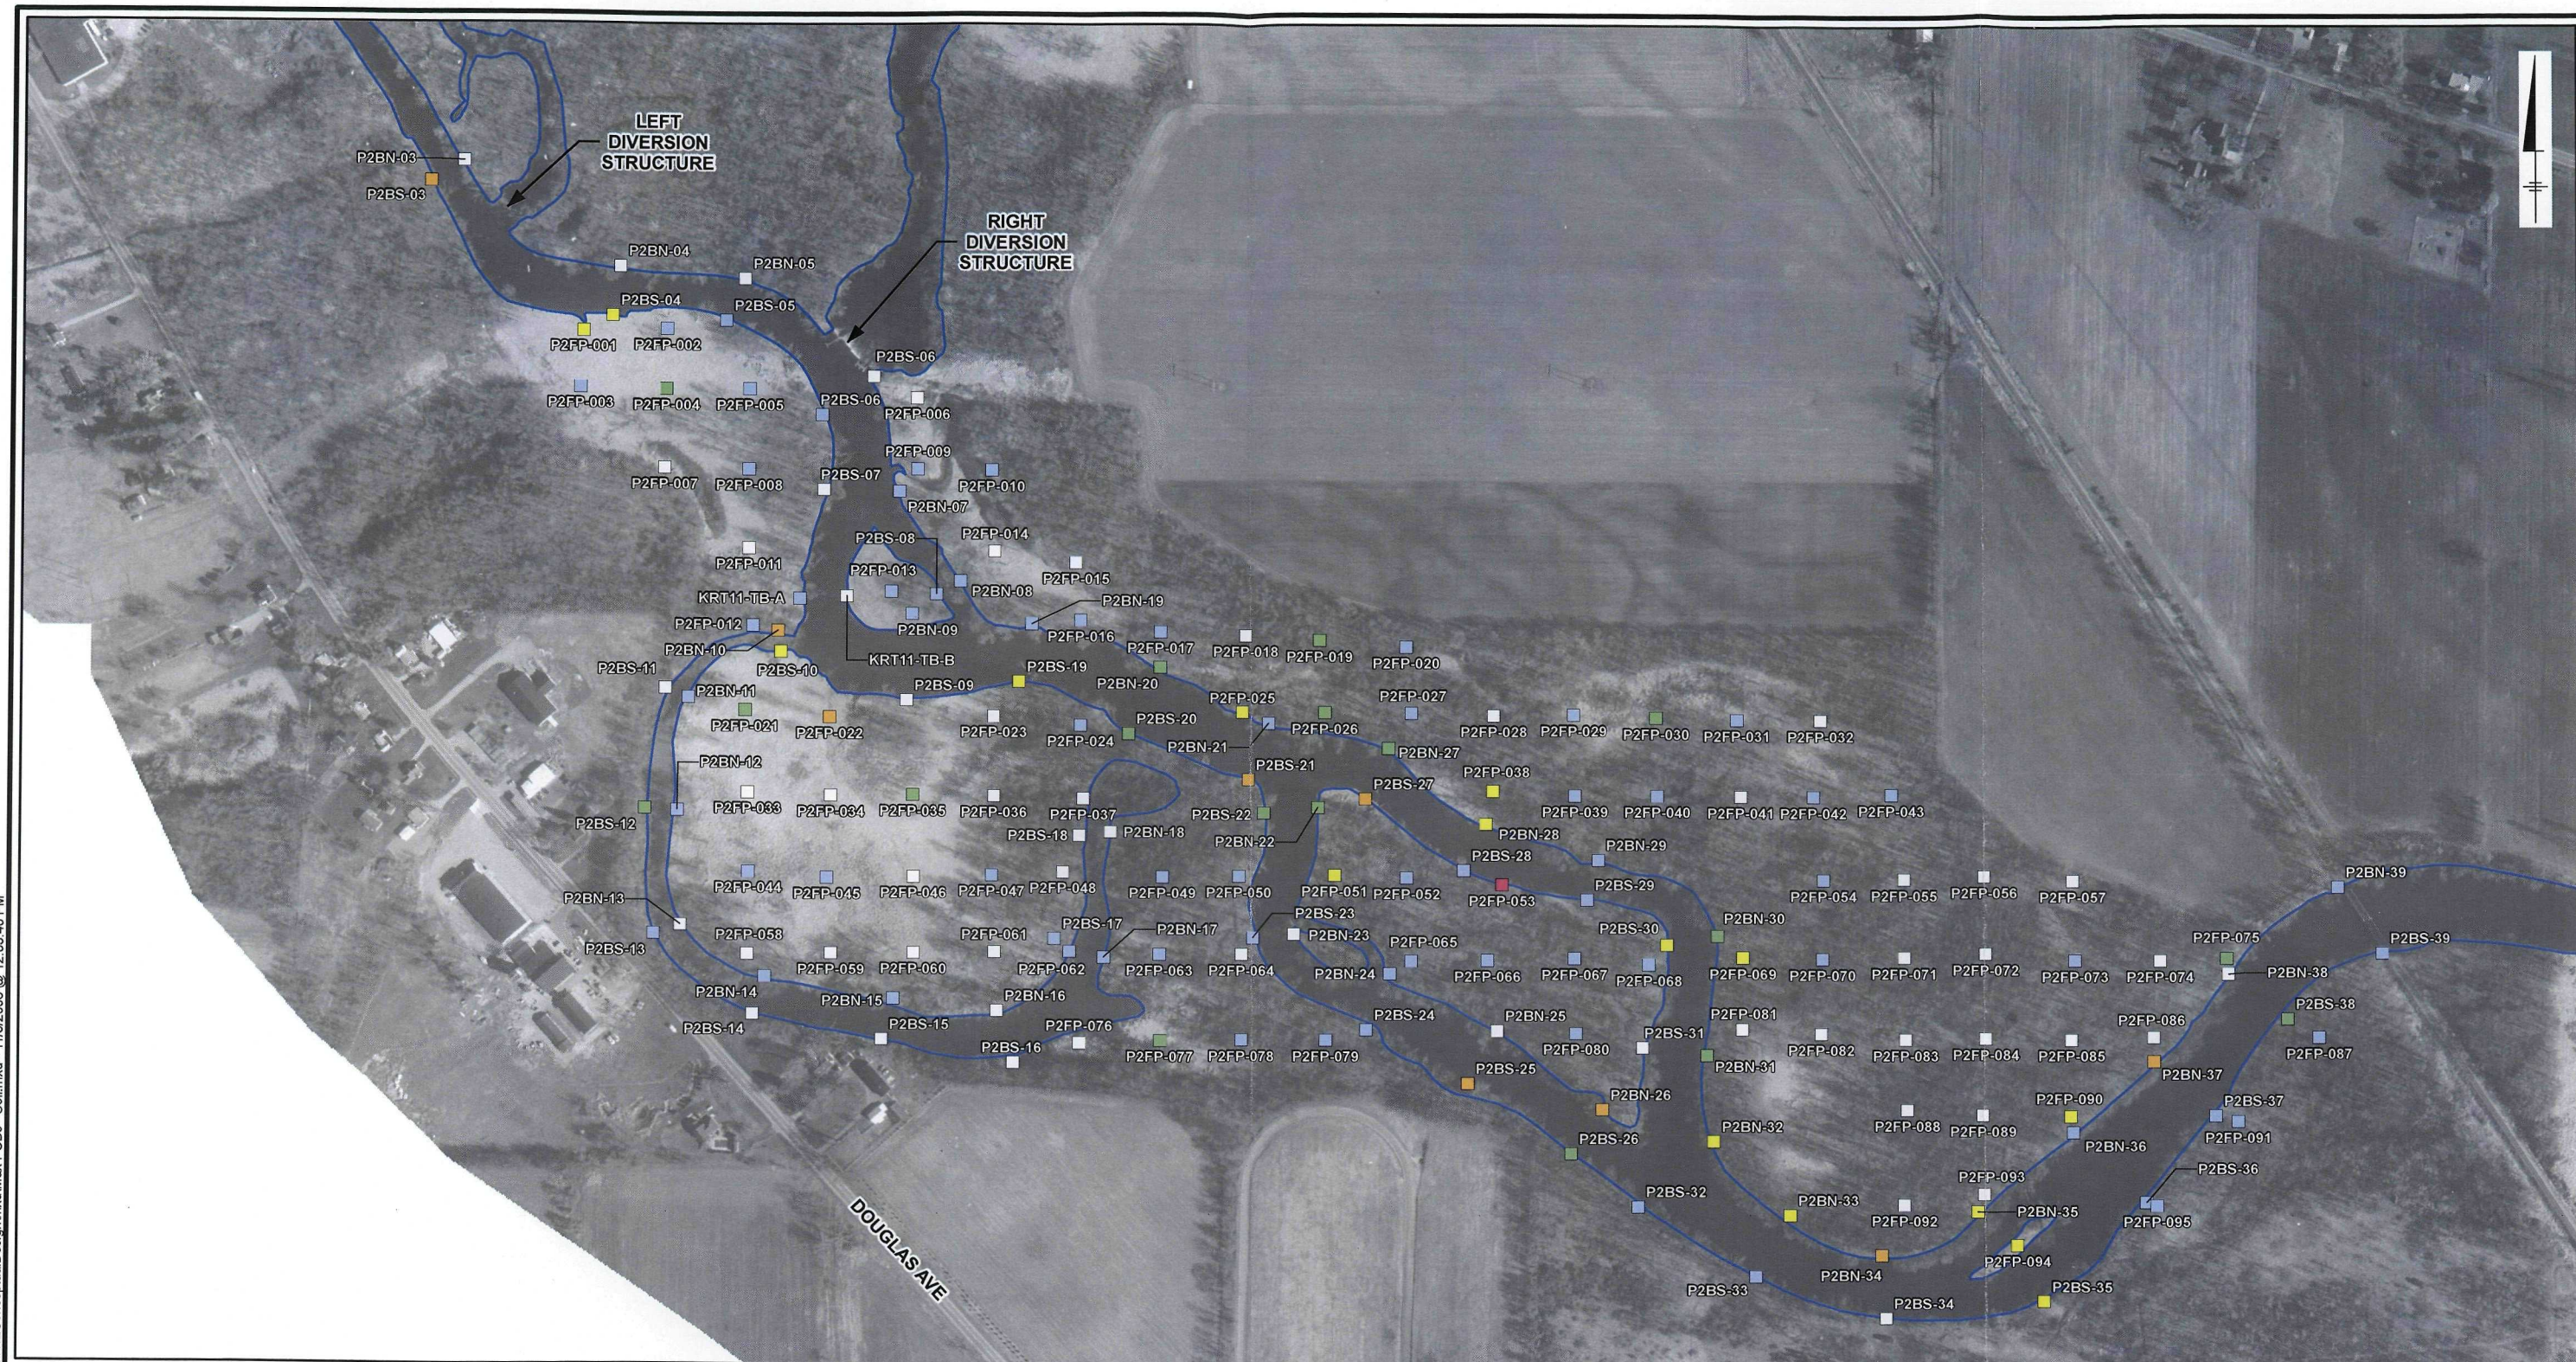
FIGURE
5

**PLAINWELL NO. 2 DAM AREA
MAXIMUM PCB RESULTS - SOIL**

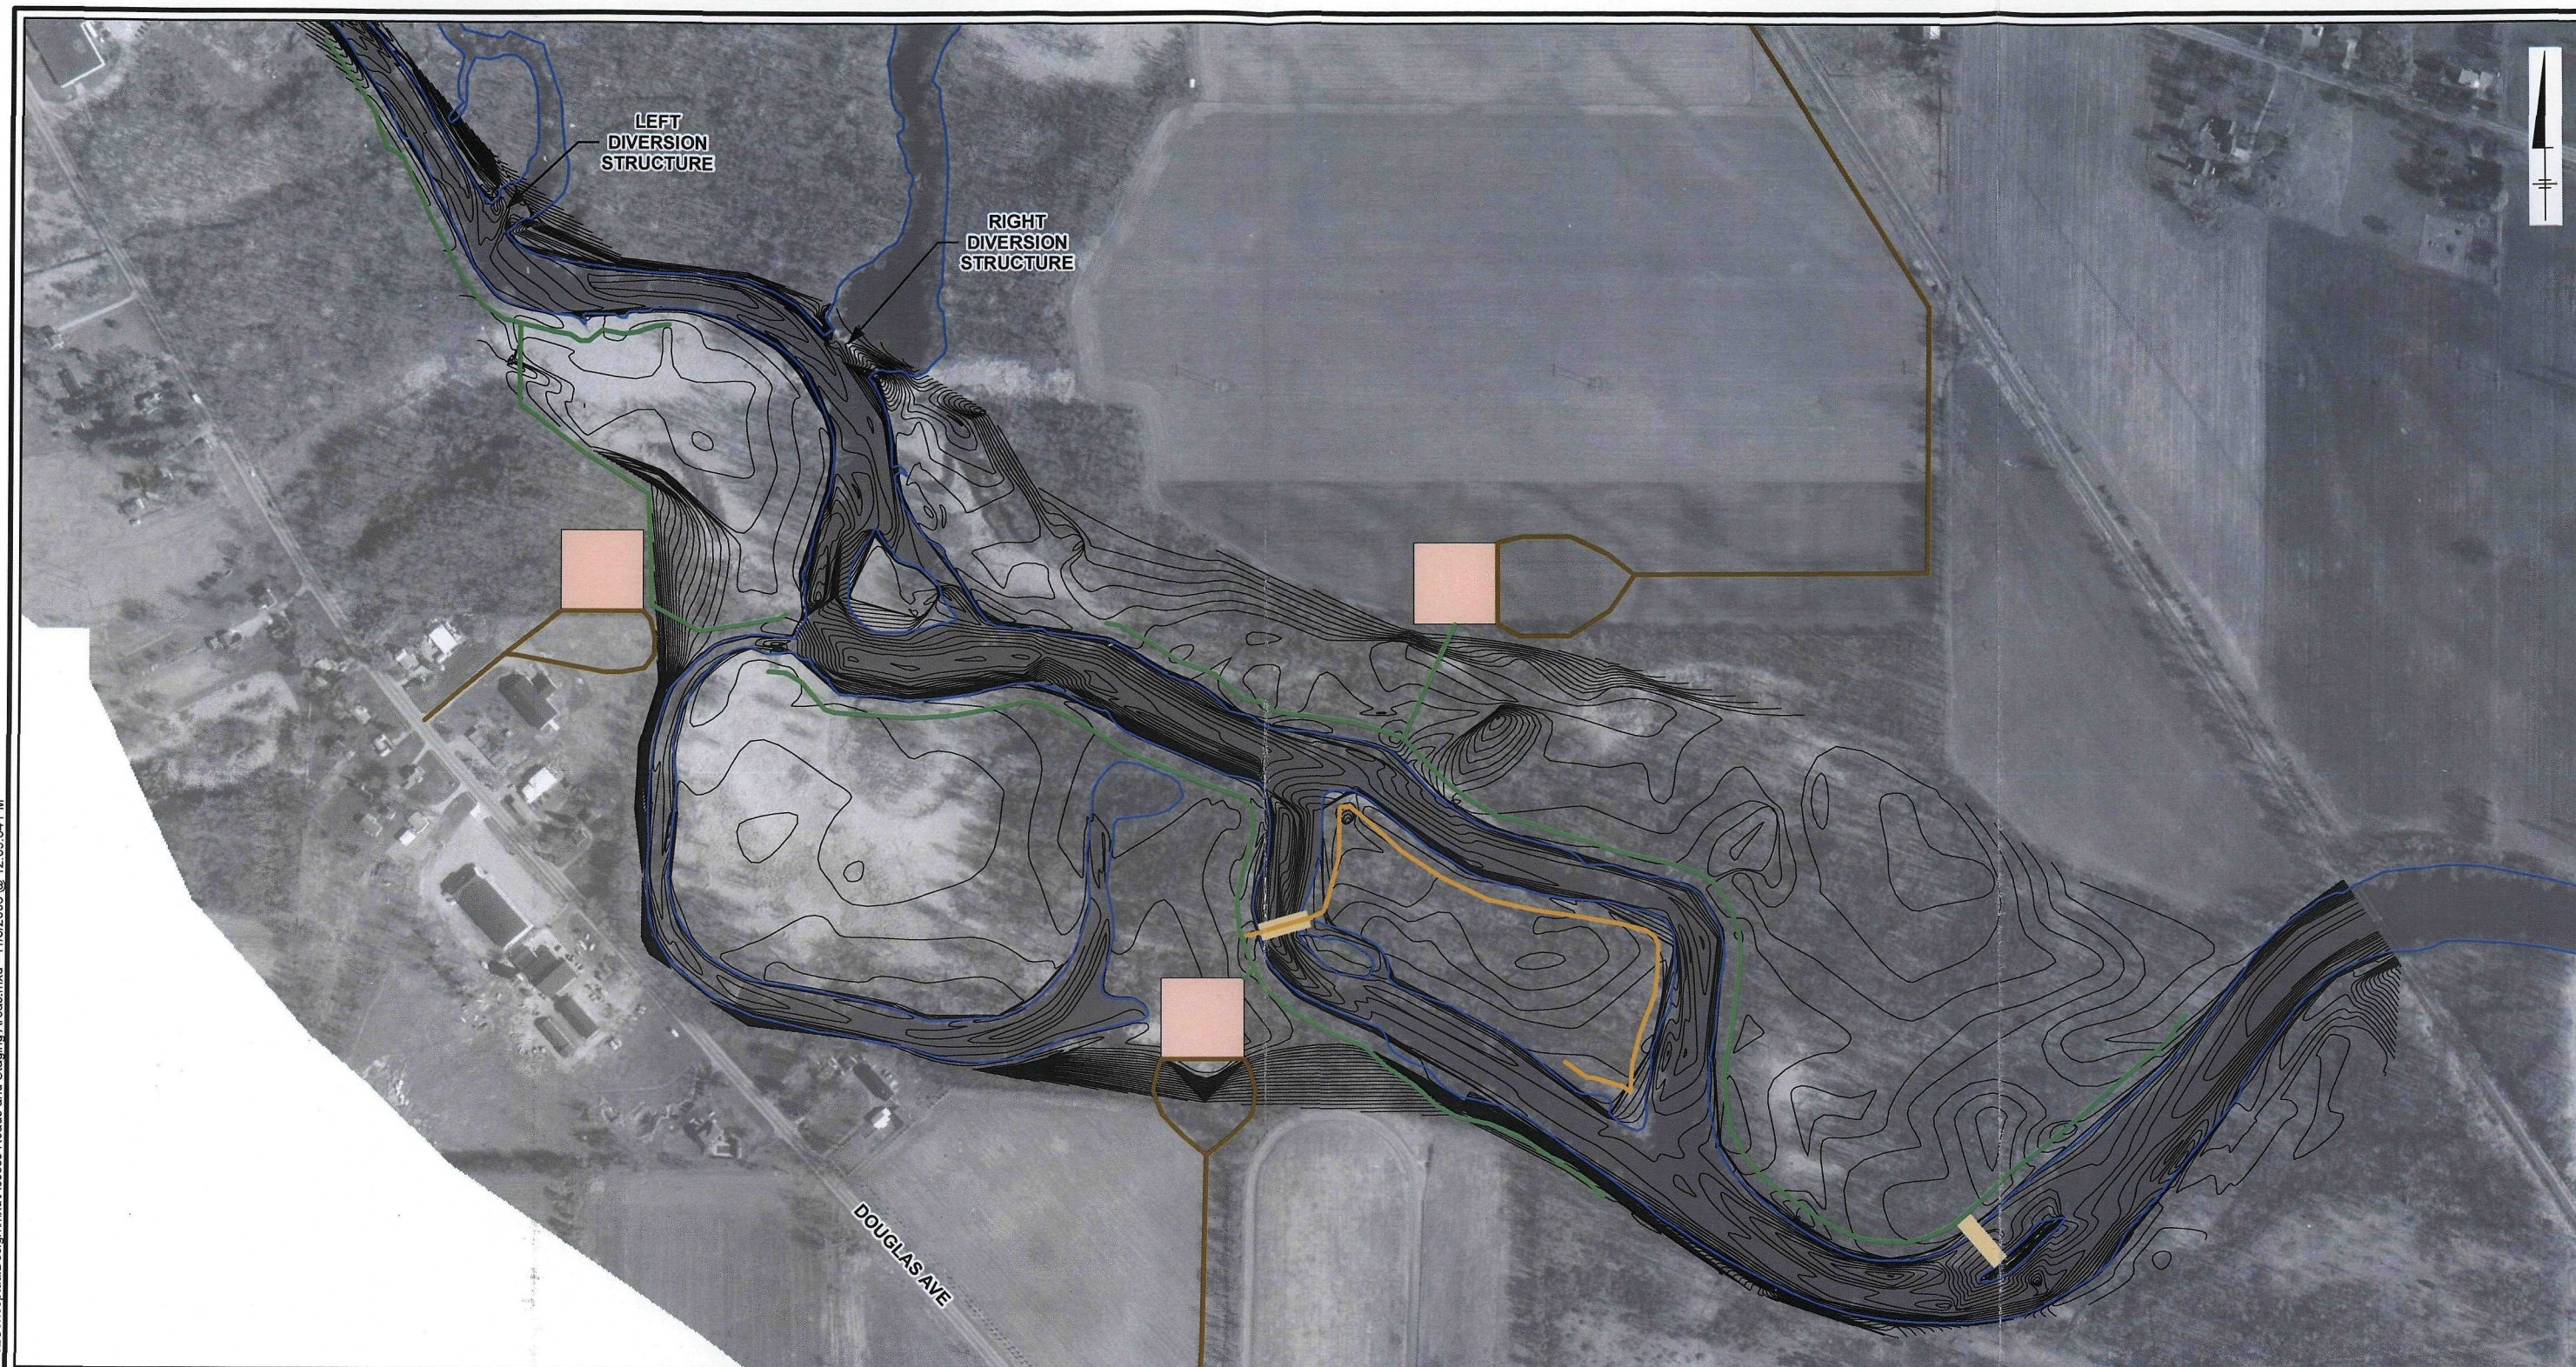
FIGURE
15

The network of access roads will be constructed to support safe and efficient travel of vehicles to execute the work. Access roads will be typically constructed from crushed stone (a portion of the material would likely be similar materials recycled from the Plainwell TCRA project) underlain with geotextile, but the specific composition of materials will depend on location-specific conditions (e.g., bearing capacity of underlying soils) and the type of traffic expected (e.g., off-road dump trucks for onsite transfer vs. tractor trailers for offsite transport). Improvements such as structural geotextile or mats may be necessary to bridge over soft or saturated soils. Tracked soils or sediments will be periodically removed from the access roads. Control measures such as using lined trucks, performing additional solidification, or reducing truck loads will be implemented where needed to minimize the loss of material while hauling.

Low ground pressure equipment for soil removal and hauling (e.g., tracked haulers) may be used in cases where access road construction may be less practical due to the limited bearing capacity of underlying soils. Due to geotechnical information needs and the seasonal variability associated with the strength of surface soils, field conditions will be assessed by the construction management staff during access road construction to determine the portions of the project area where the use of low ground pressure equipment would be appropriate.
